BOEING VERTOL CO PHILADELPHIA PA  
SMALL HARDWARE DESIGN FOR EASE OF MAINTENANCE AND INSPECTION.(U)  
MAR 77 L D BARRETT  
D210-11081-1

**SMALL HARDWARE DESIGN FOR EASE OF  
AND INSPECTION**

Boeing Vertol Company  
P.O. Box 16858  
Philadelphia, Penn. 19142

March 1977

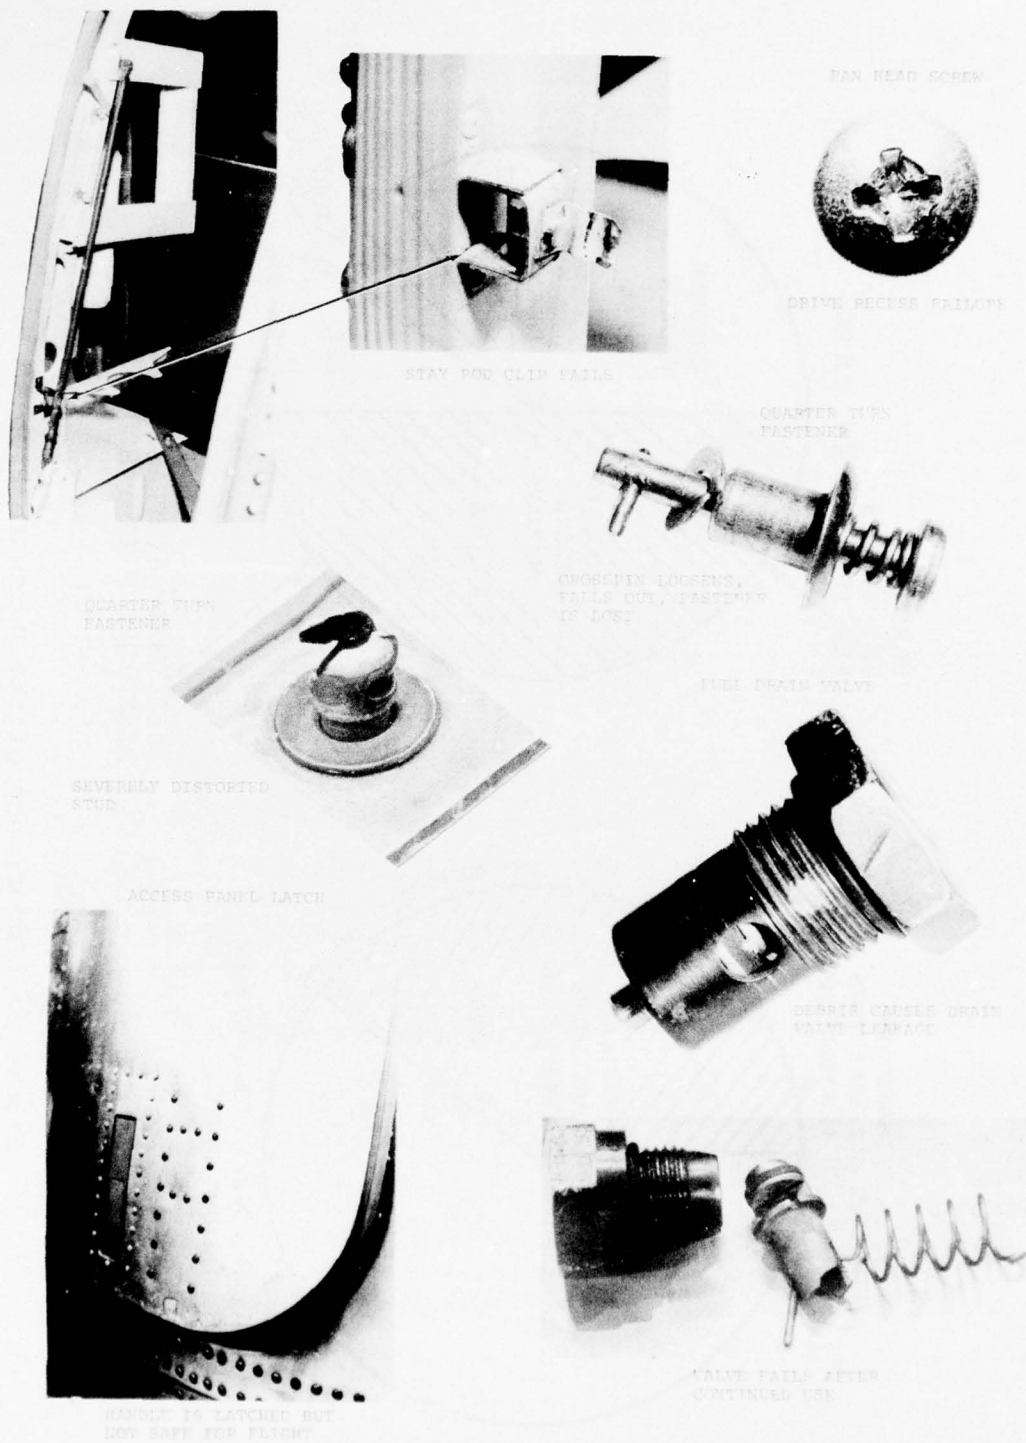
Figure 1. Typical Small Hardware Problems

Typical malfunctions of these six items were shown in Figure 1.

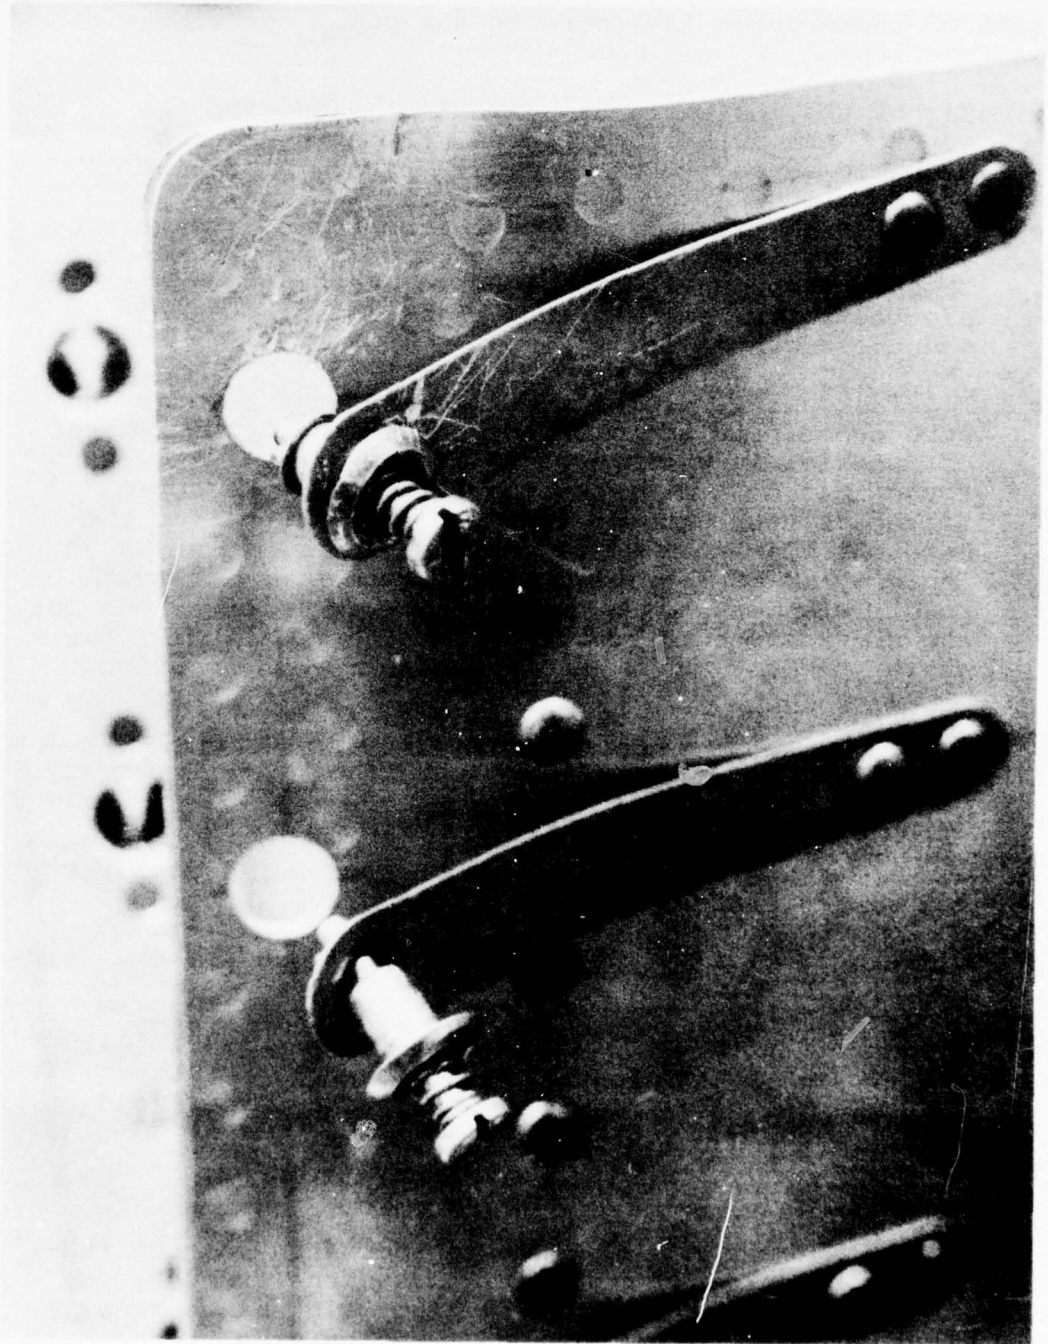
Figure 18. Present Fastener Installation

The CH-47 induction system fairing access panel currently uses quarter-turn fasteners made by the Specialty Fastener Division of Rexnord, Inc. These "Camloc" Series 2600 fasteners, shown in Figure 18, consist of alloy-steel stud assemblies and stainless steel receptacles. The stud assembly is secured by a retaining washer to an ejector spring which is riveted to the opening panel. The receptacle is riveted to the fairing structure.

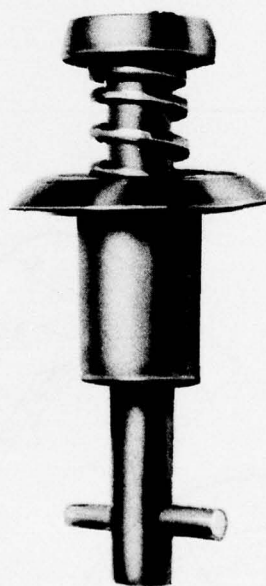
Figure 27. Shearing of Cross Pin

- The loosening or loss of the stud cross pin as illustrated in Figures 22 and 26.
  - The bending or shearing of the stud cross pin as illustrated in Figure 27.
2. Rounding out of the Phillips recess.
  3. Panel damage from the slipping of the flat-bladed screwdriver in the slotted recess of the fastener.
  4. Failure of the fastener stud to eject from the panel whenever shear forces on the panel provided sufficient frictional resistance to overcome the ejecting spring.
  5. Failure of the fastener stud to eject from the panel because the stud retaining washer caught on the edge of the panel hole.

SHEARED  
CROSS PIN

BENT  
CROSS PIN

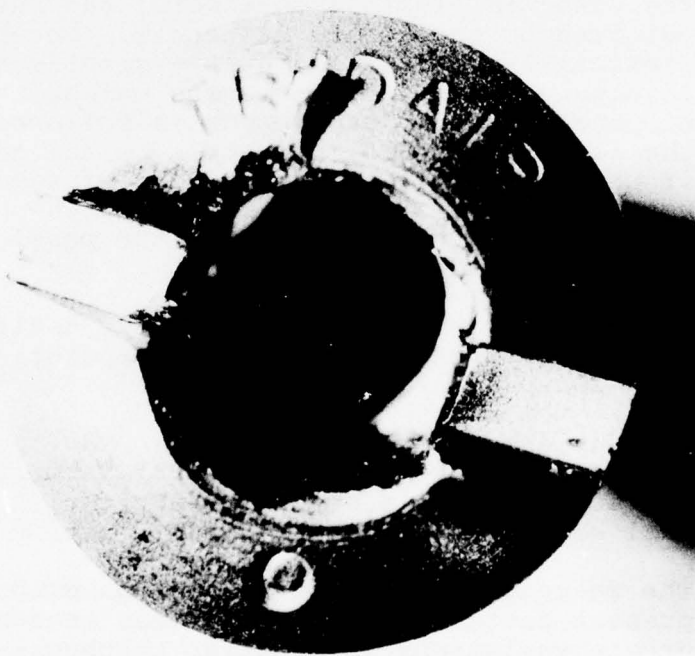
Figure 29. Candidate Replacement Fastener--Redundant Drive Recess

1. The fastener head is excellent. The redundancy of this design (shown in Figure 29) permitted fastener operation with a slotted screwdriver, an Allen hexagonal key or an Allen screwdriver bit.
2. The fastener has double the design grip range of the present fastener so there is less tendency for tolerance variations in material thickness to result in an over- or under-grip condition.
3. The fastener has a ratchet-type device to prevent stud loosening and does not rely on over-center operation. It retains the stud at any position of engagement.
4. The fastener receptacle can be easily field replaced without special tools.

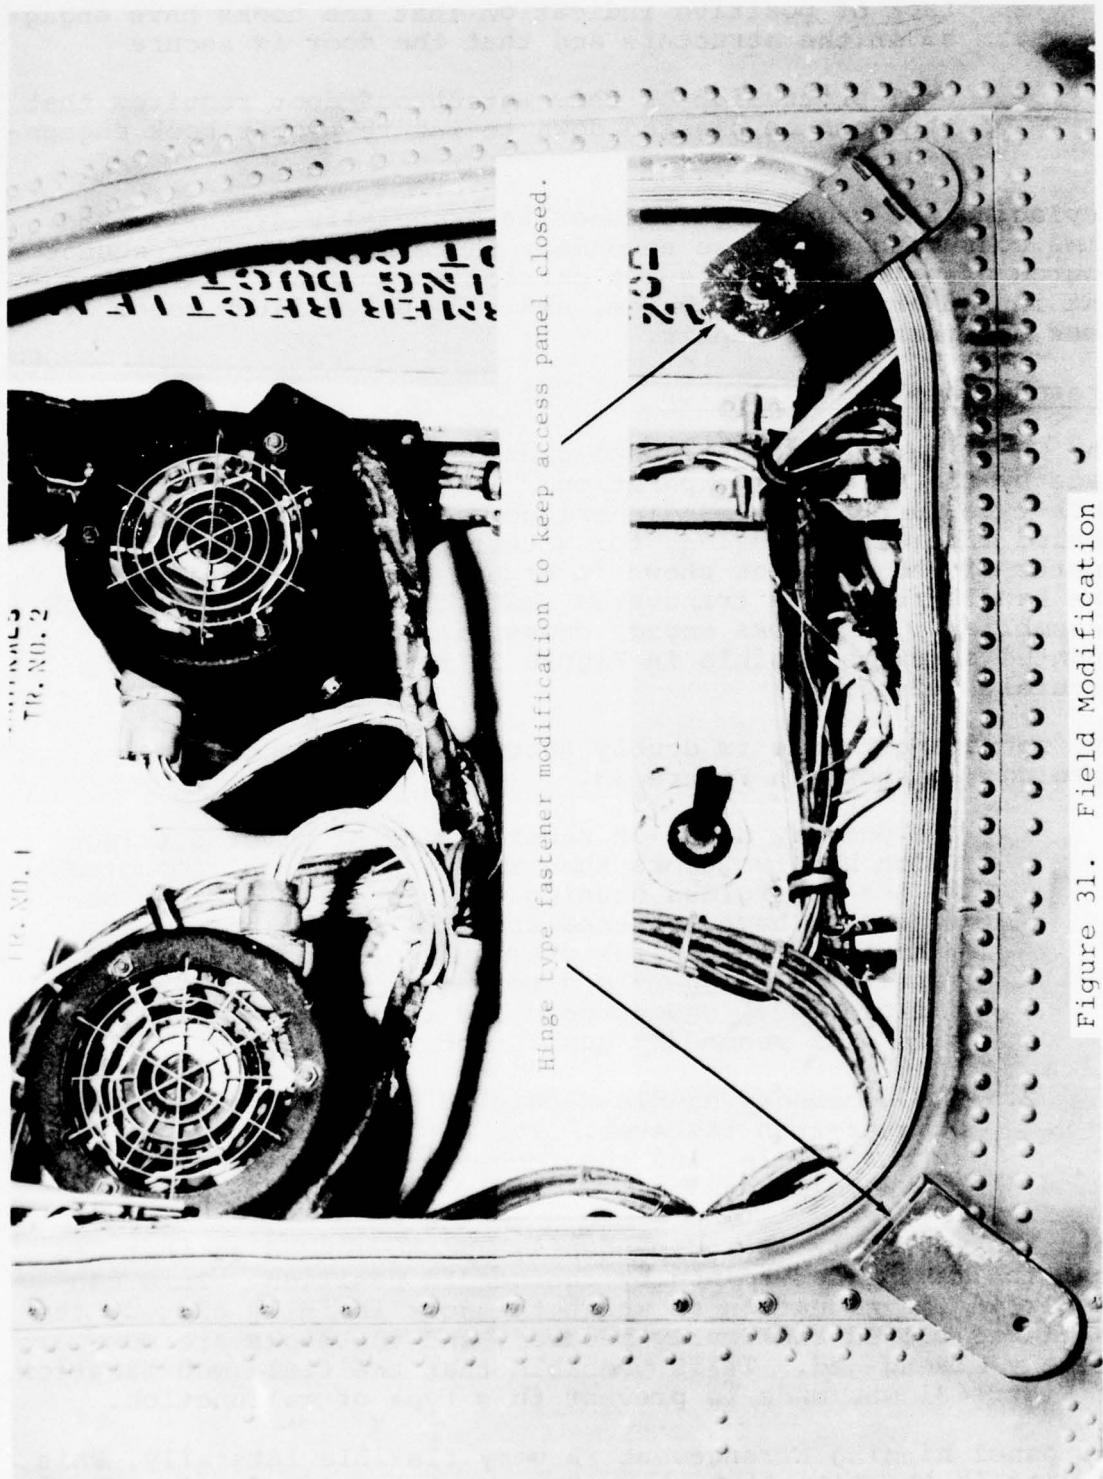
Figure 31. Field Modification

Each hook assembly is independently spring-loaded so that its position is not determined by the handle position. This can result in the situation in which the door is fully closed, the handle is closed and doubly secured, and the hooks are completely disengaged. It is probable that the field modification of Figure 31 was made to prevent this type of malfunction.

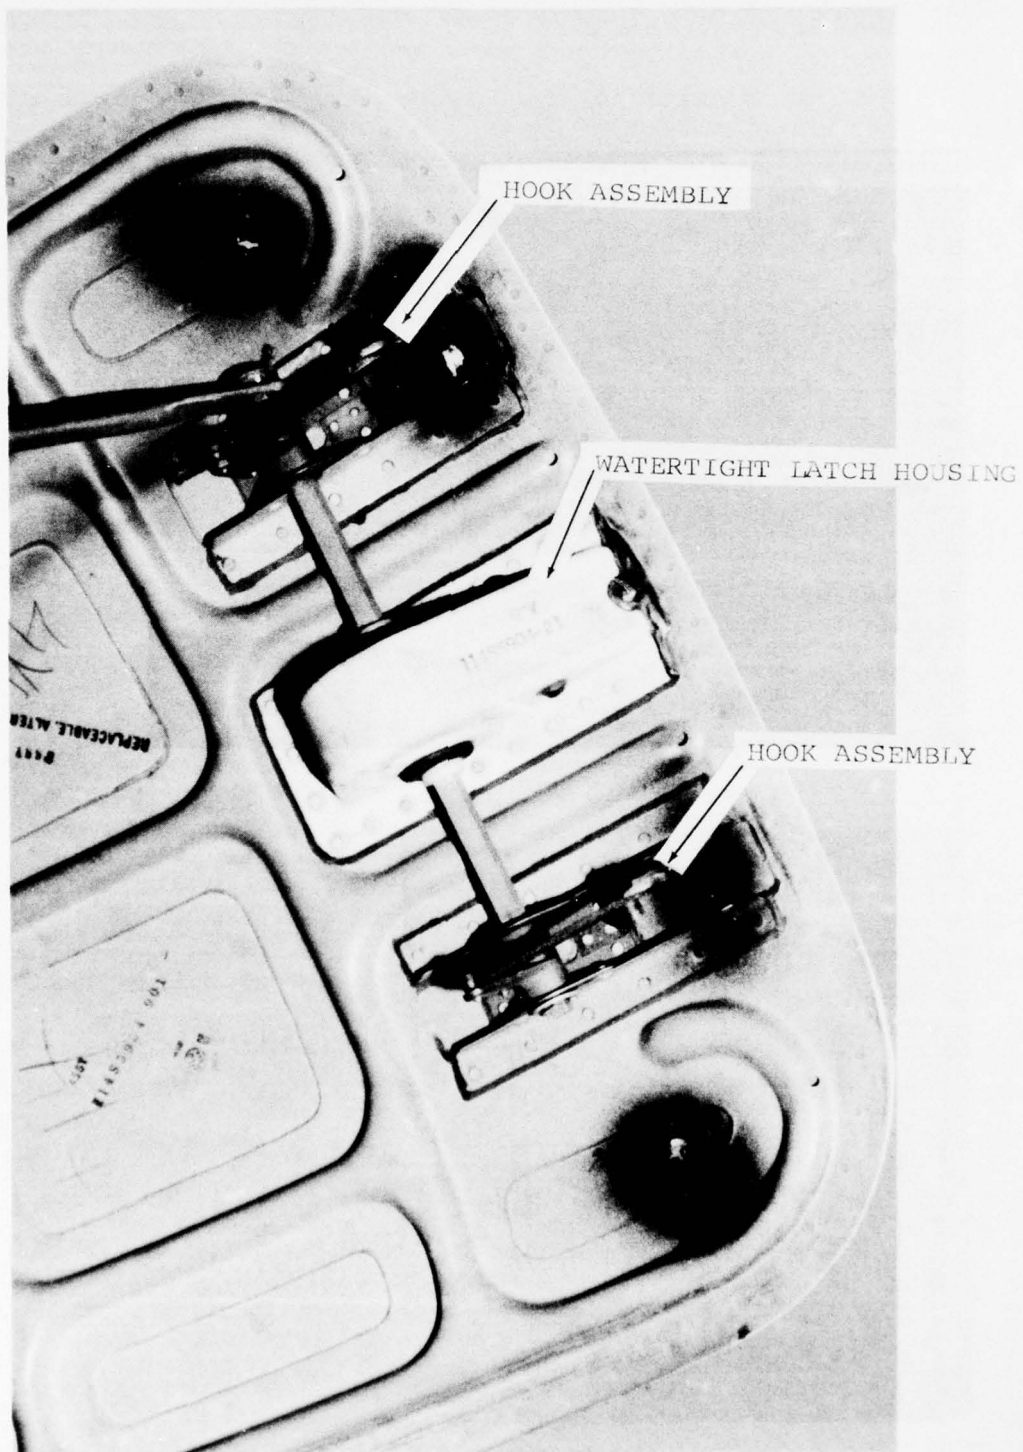
Figure 32. Latch Details

The CH-47 battery access panel presently uses latch components made by the Hartwell Corporation. This is a trigger-action, hook-type latch. The handle-trigger assembly is mounted in a sealed fiberglass housing, for watertightness, in the lower center of the panel as shown in Figure 32. The operation of the handle rotates a transverse shaft to actuate the two hook assemblies. The hooks engage cross pins in the structure-mounted brackets visible in Figure 30 to keep the panel securely closed.

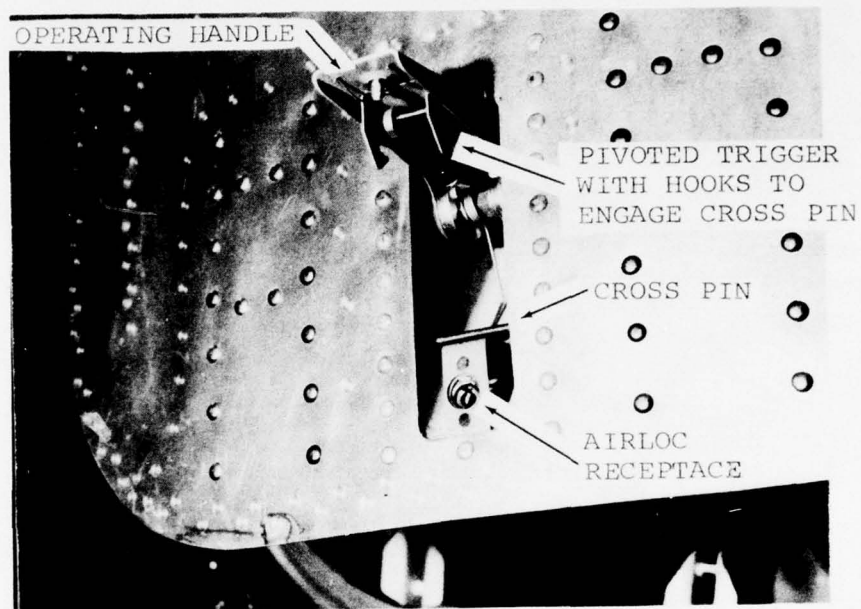
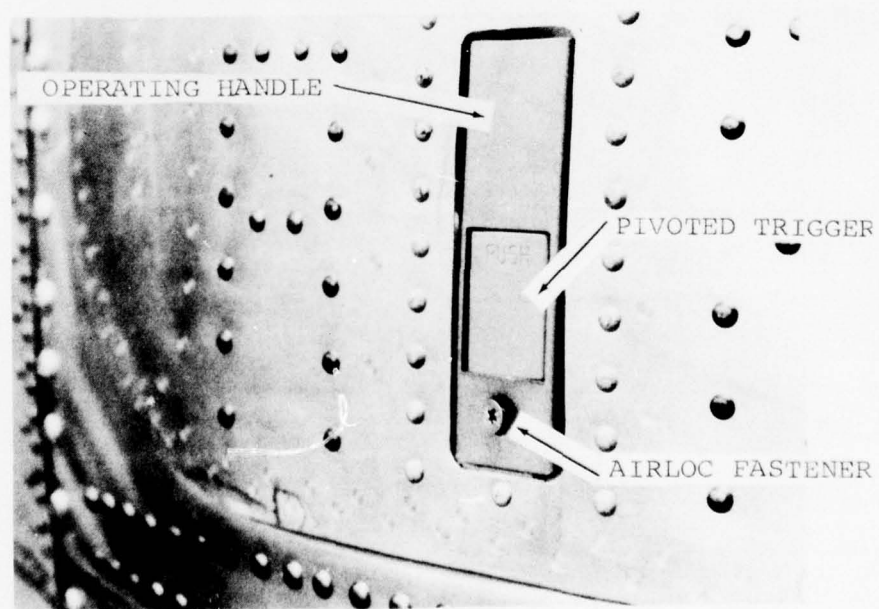
Figure 33. The Double Securing Operating Handle

The operating handle is doubly secured against accidental opening, as shown in Figure 33.

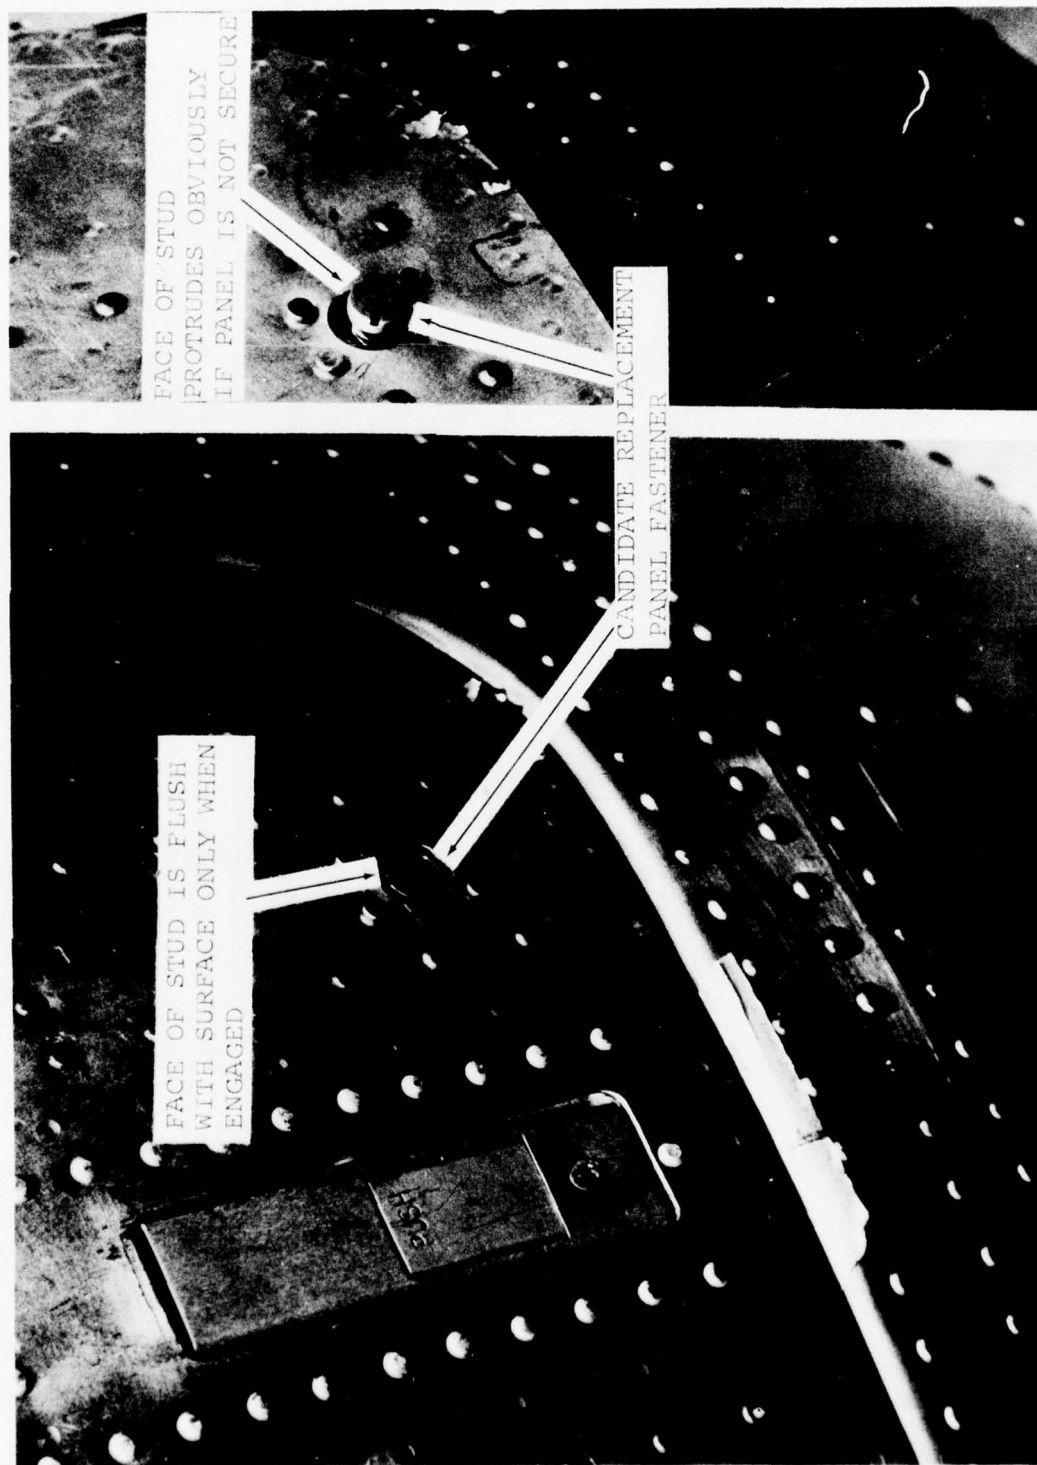
Figure 35. Security of Panel Shown by Fastener Head

The spring-loaded stud is flush with its housing when engaged, and protrudes in an obvious manner, away from the face of the panel, when disengaged. This gives a visual indication of the security of the panel, as shown in Figure 35. The conical face of the stud housing nests in a conical recess in the receptacle so as to be self-aligning and easily engaged in spite of the compound panel curvature and inclined hinge axis.

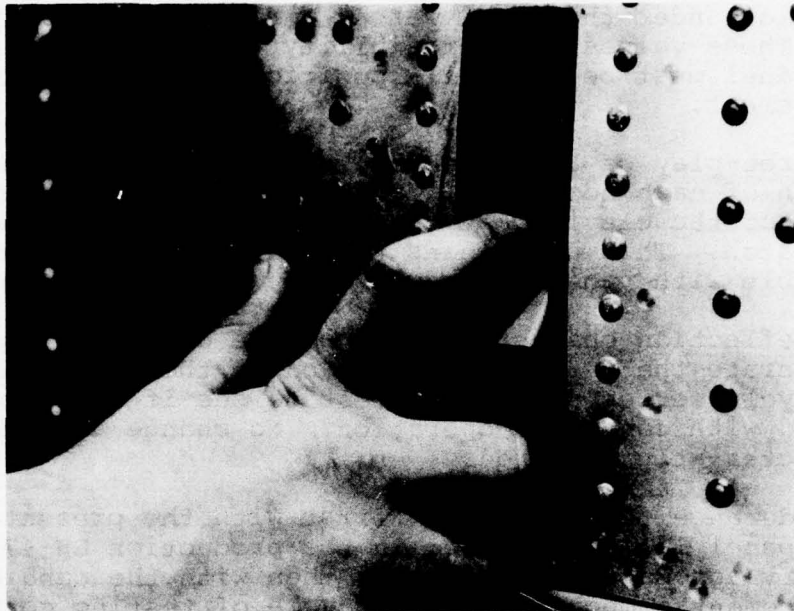
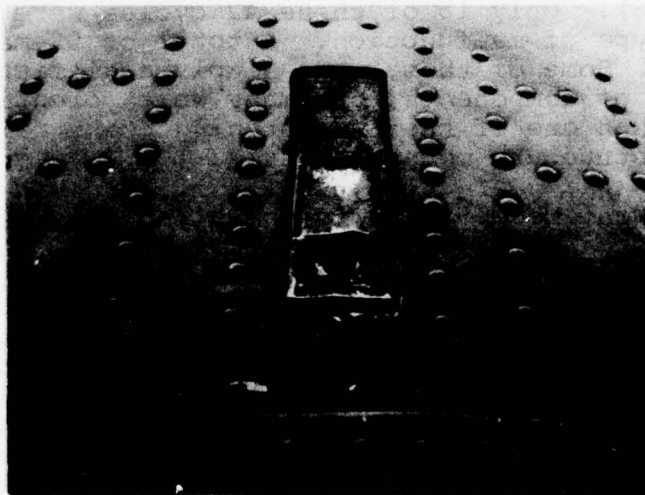
Figure 37. Trigger Release Operation

7. The trigger mechanism forces are affected by latch tension forces. If latch forces are high, it is difficult to engage and disengage the trigger. The trigger is released by pressing with one's thumb or finger. If the release forces are high, the trigger has a tendency to snap "in", and one's thumb gets scraped by the edge of the handle (Figure 37).

TO AVOID SCRAPING YOUR FINGER WHEN THE TRIGGER SNAPS IN -  
USE A SCREWDRIVER

AT LEAST YOUR FINGER DOESN'T GET SCRAPED

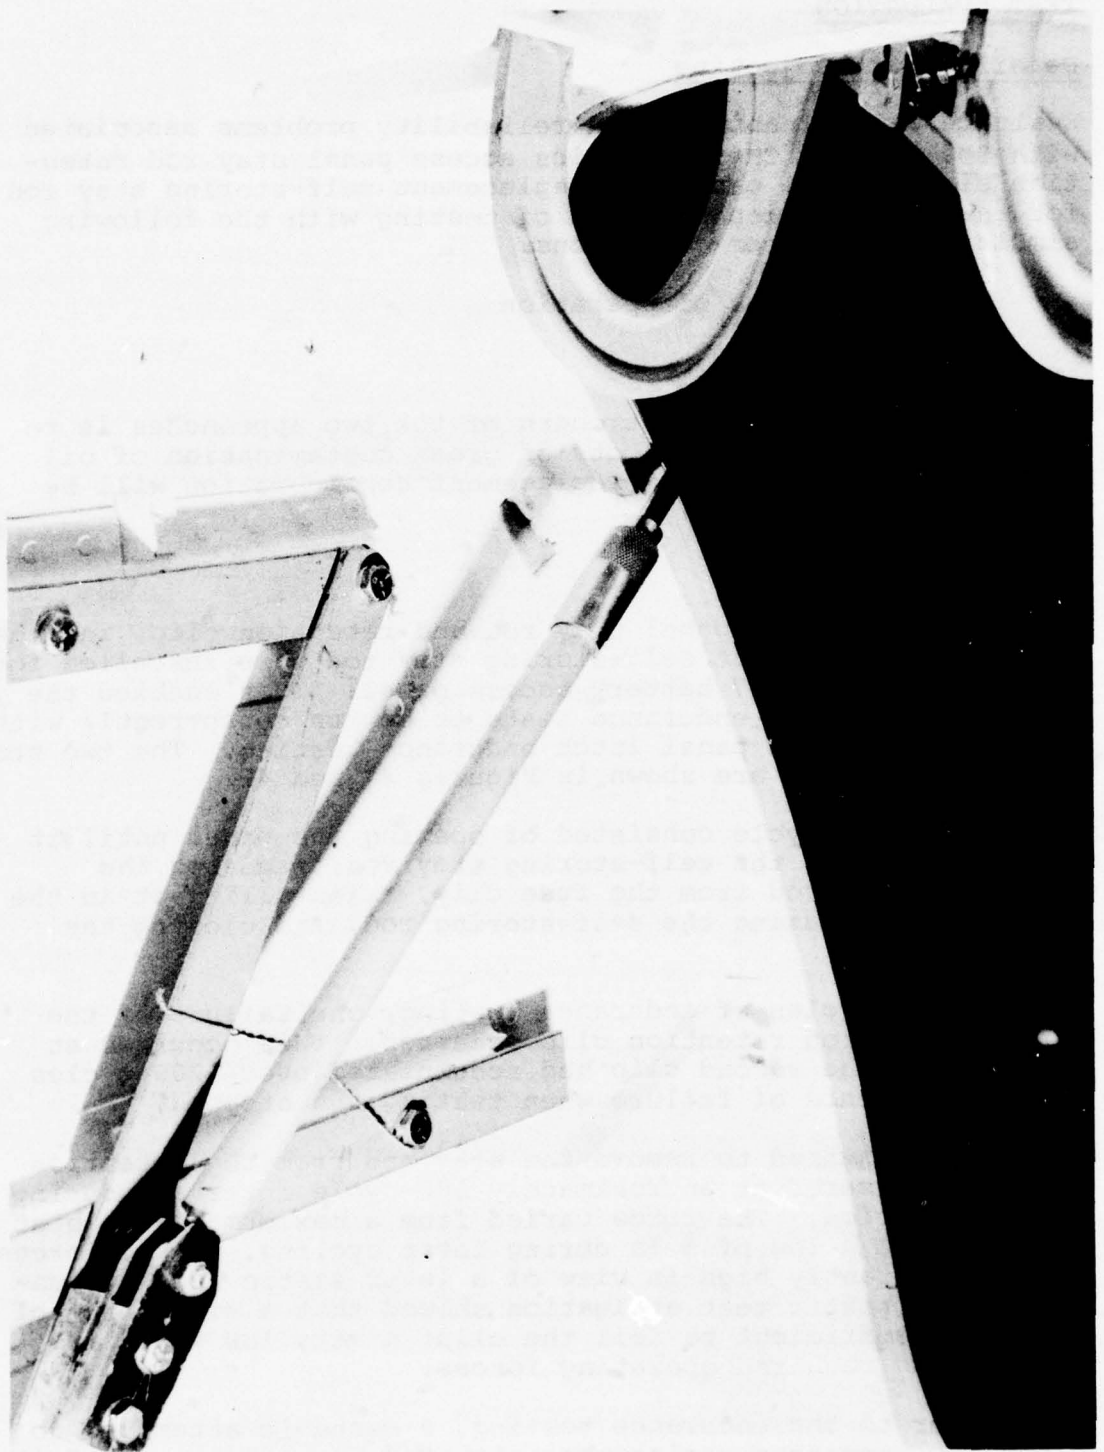
Figure 42. Candidate Replacement Stay Rod Installed for Test

Just prior to the endurance testing, a mechanic attempted to close the candidate replacement stay rod for storage and failed the release assembly. He explained that he did not understand

the method of operation of the rod and that he pushed, pulled and twisted the release sleeve until the rod failed.

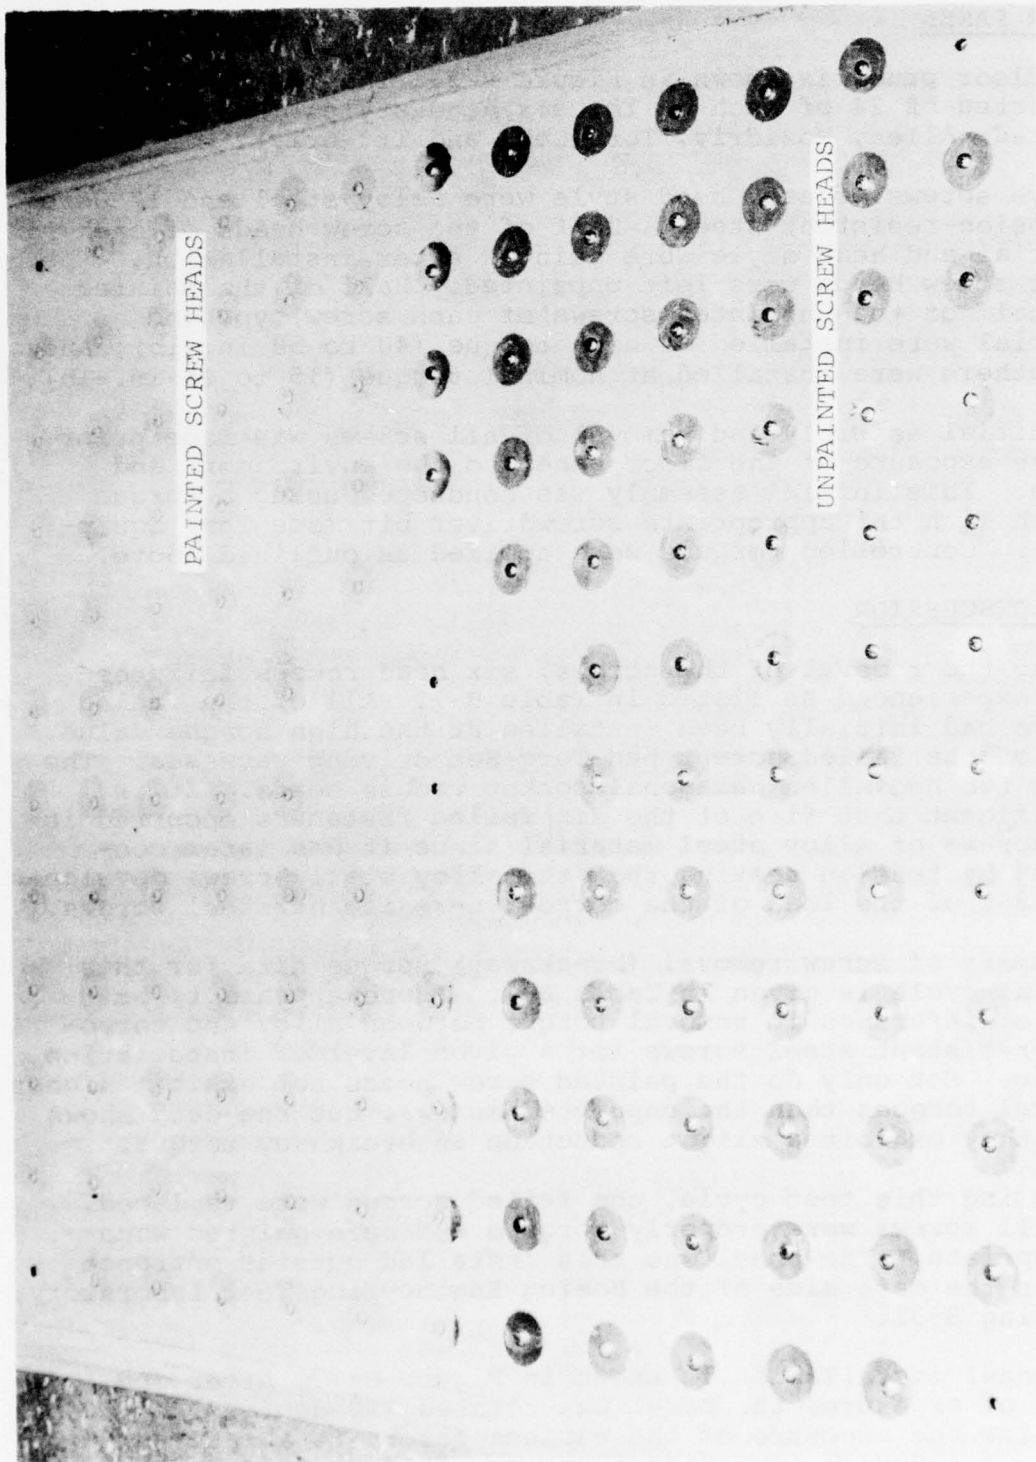
Figure B-2. Floor Panel

During the removal of the screws, six head recess failures were experienced as listed in Table B-1. All of the failed screws had initially been installed at the high torque value. Four of the failed screws had Torq-Set driving recesses. The other two had Allen hexagonal socket recess heads. It is significant that five of the six failed fasteners occurred in the screws of alloy steel material since it was later confirmed by tension testing that the alloy steel screws developed only 80% of the load of the corrosion-resistant steel screws.

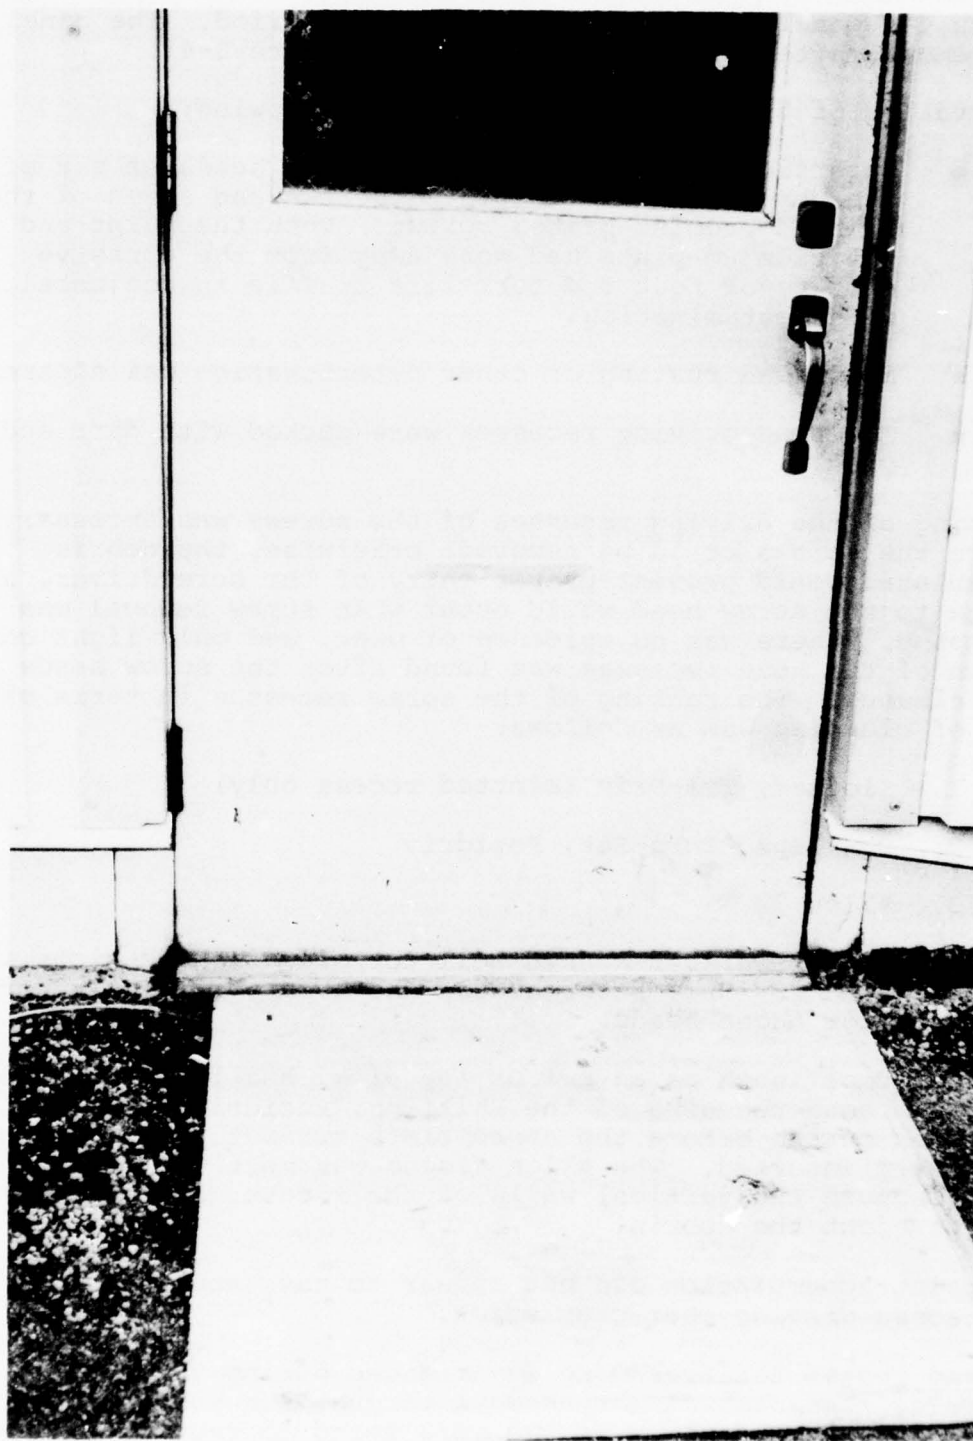
Figure B-3. Floor Panel Installation

The panel installation is shown in Figure B-3. After one month of exposure, the panel was rotated 180 degrees to equalize the exposure of the various screws to abrasive wear. A 4,000-lb fork lift truck was deliberately driven

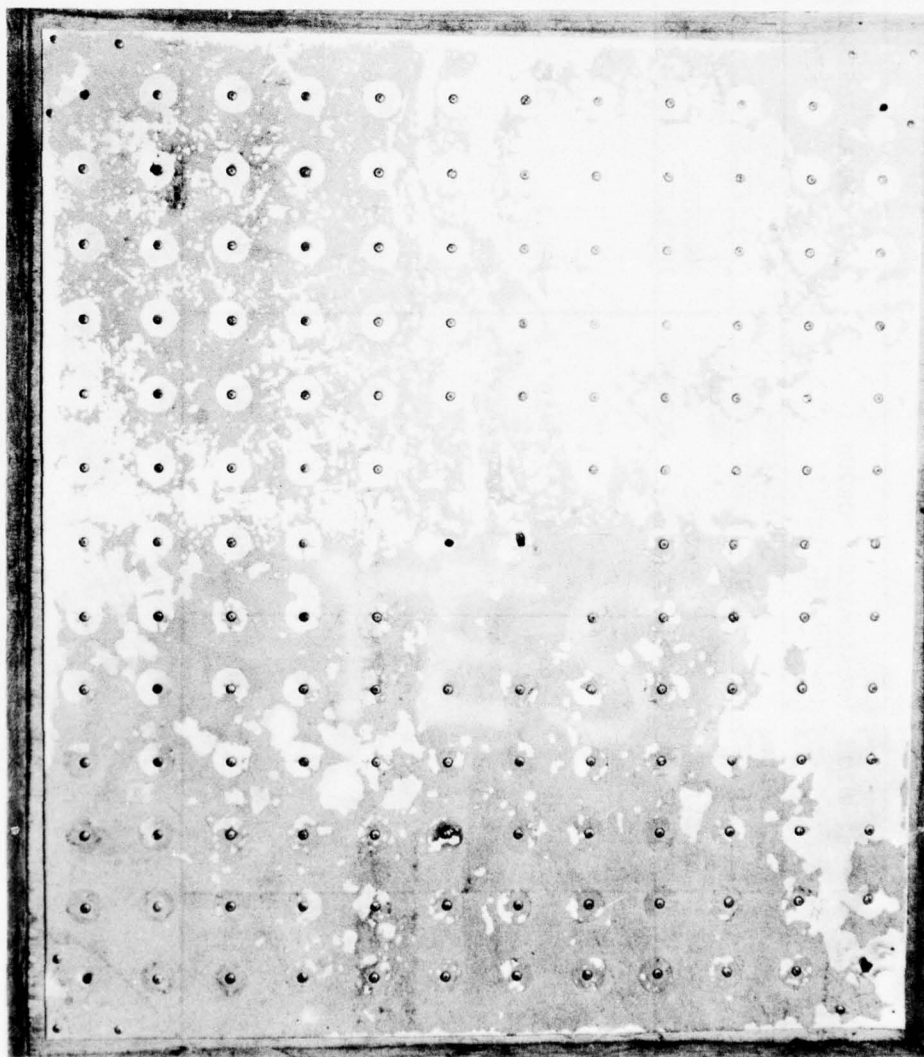
Figure B-4. Floor Panel After Removal

across the panel 30 times during the test period. The panel was removed after two months' exposure (Figure B-4).

- Superficial rust was present on the heads of six of the unpainted cadmium-plated screws and seven of the painted cadmium-plated screws. Both the paint and the cadmium plate had worn away from the abrasive effects of foot and fork lift traffic in conjunction with contamination.
- No thread rusting or other deterioration was apparent.
- The head driving recesses were packed with dirt and grit.

Cleaning of the driving recesses of the screws was necessary before the screws could be removed; otherwise, the debris accumulated would prevent proper entry of the screwdriver, and damage to the screw head would occur when screw removal was attempted. There was no evidence of wear, and only light corrosion of the head recesses was found after the screw heads were cleaned. The ranking of the screw recesses in terms of ease of cleaning was as follows:

No head recess failures were experienced during the screw removals. The removal (breakaway) torques are summarized in Table B-3. The alloy screws were found to require approximately 25 percent more breakaway torque than the corrosion-resistant screws for a given level of installation torque. After the environmental exposure, the values of breakaway
